ARMY ENGINEER WATERWAYS EXPERIMENT STATION VICKSBURG--ETC F/G 8/6  
ENGINEERING GEOLOGY AND GEOMORPHOLOGY OF STREAMBANK EROSION. RE--ETC(U)  
OCT 81 C B WHITTEN, D M PATRICK

4. TITLE (and Subtitle) ENGINEERING GEOLOGY AND GEOMORPHOLOGY OF STREAM- BANK EROSION; Report 2, YAZOO RIVER BASIN UPLANDS, MISSISSIPPI	5. TYPE OF REPORT & PERIOD COVERED Report 2 of a series

7. AUTHOR(s) Charlie B. Whitten David M. Patrick	6. PERFORMING ORG. REPORT NUMBER Jun 77 - Aug 78	
9. PERFORMING ORGANIZATION NAME AND ADDRESS U. S. Army Engineer Waterways Experiment Station Geotechnical Laboratory P. O. Box 631, Vicksburg, Miss. 39180	8. CONTRACT OR GRANT NUMBER(s)

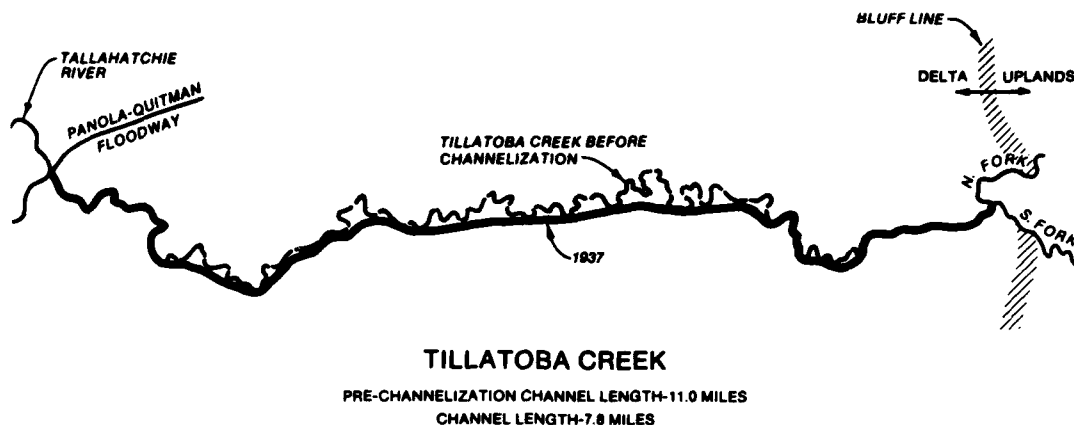
Figure 12. Tillatoba Creek before and after channelization

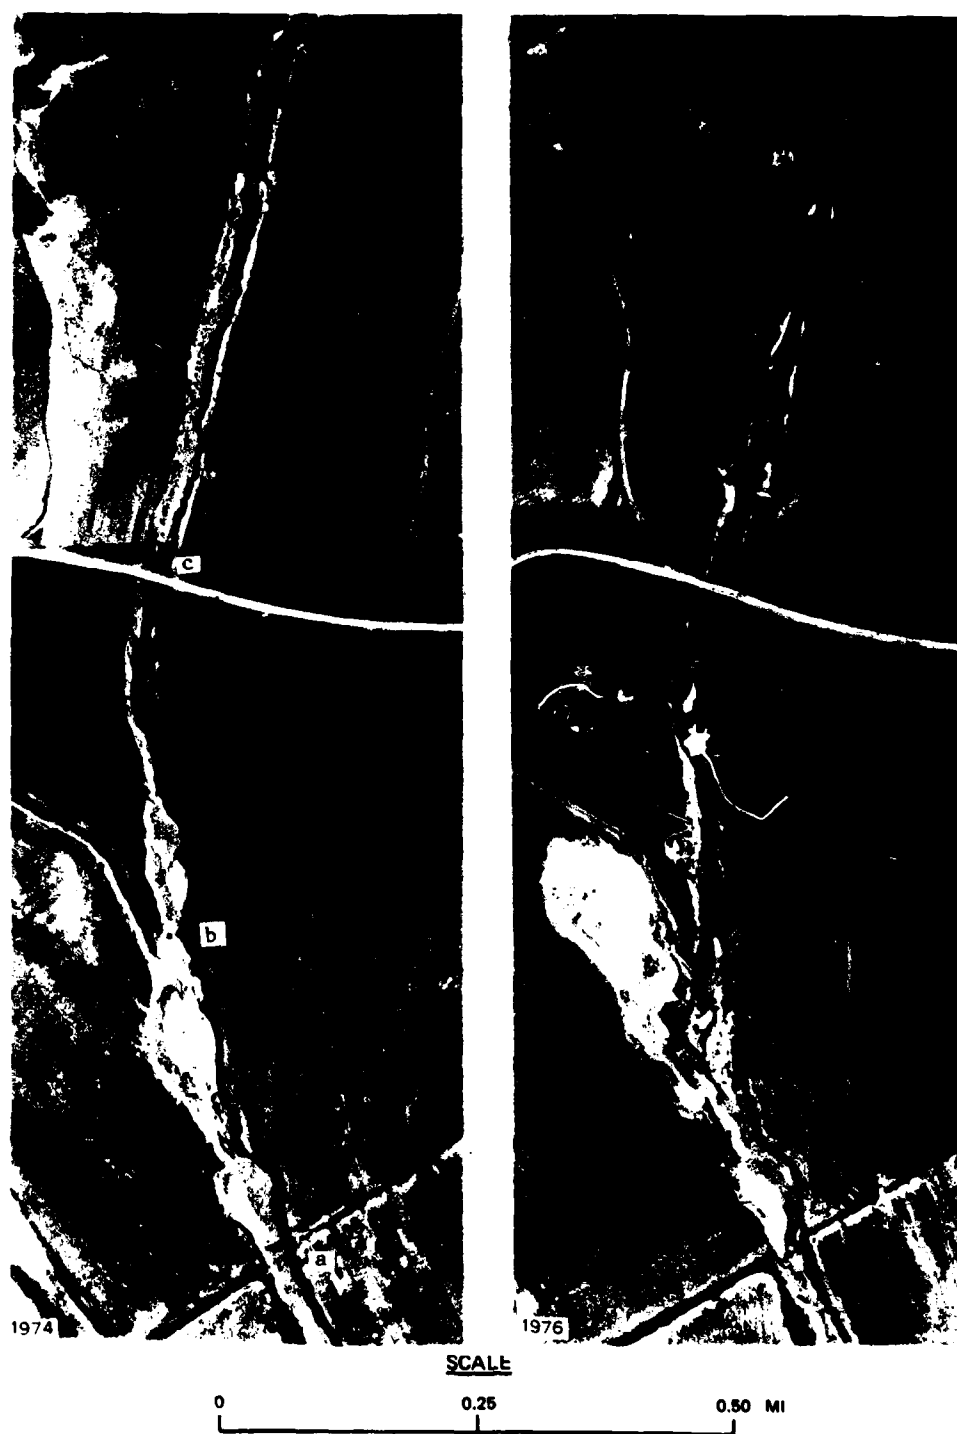
Figure 23. Channel erosion from the upstream movement of a knickpoint at site T8 (See Figure 24 for a chronological sequence of stereo photographs at locations a, b and c. Note the Indian mound to the left of location b is being leveled in the 1976 photographs.)

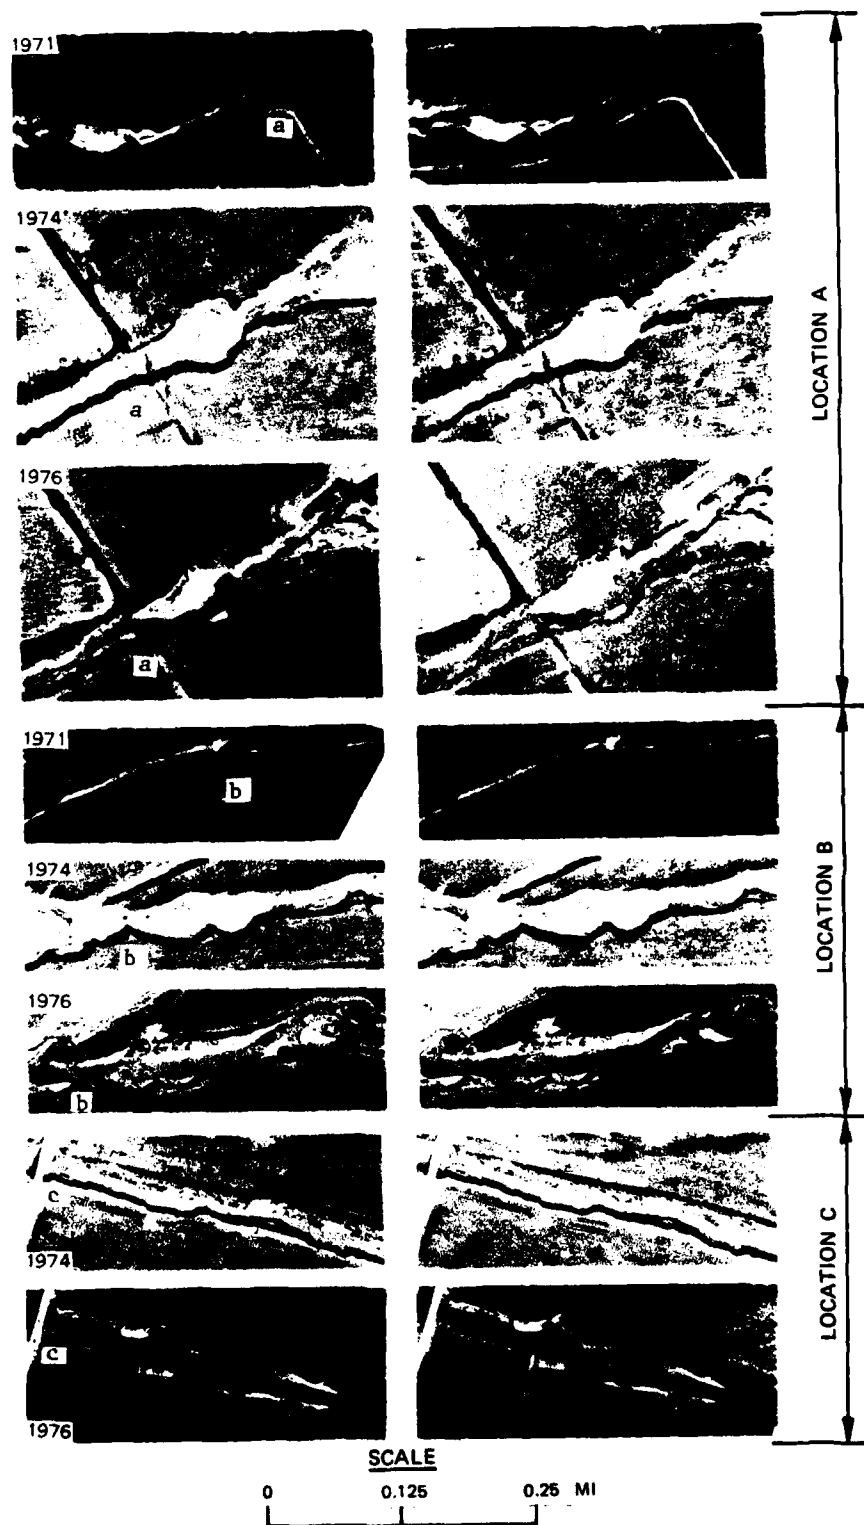
Figure 24. The upstream movement of a knickpoint at site T8  
(See Figure 23 for locations a, b and c.)

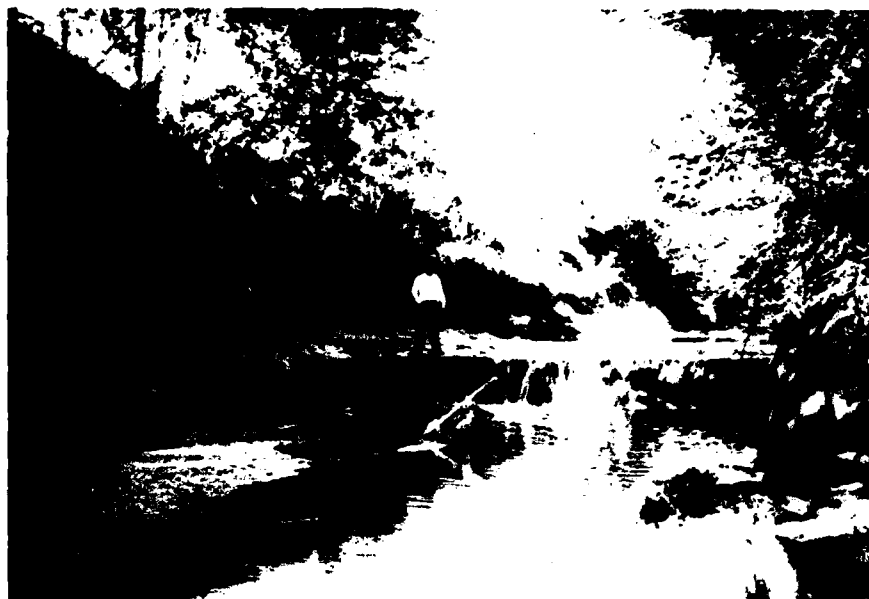
Figure 63. Knickpoint at site H4 on Hotopha Creek, 1978 (See symbol "A" on the 1977 photograph in Figures 62 and 65.)
